AGARD LECTURE SERIES 206

## Aging Combat Aircraft Fleets — Long Term Applications

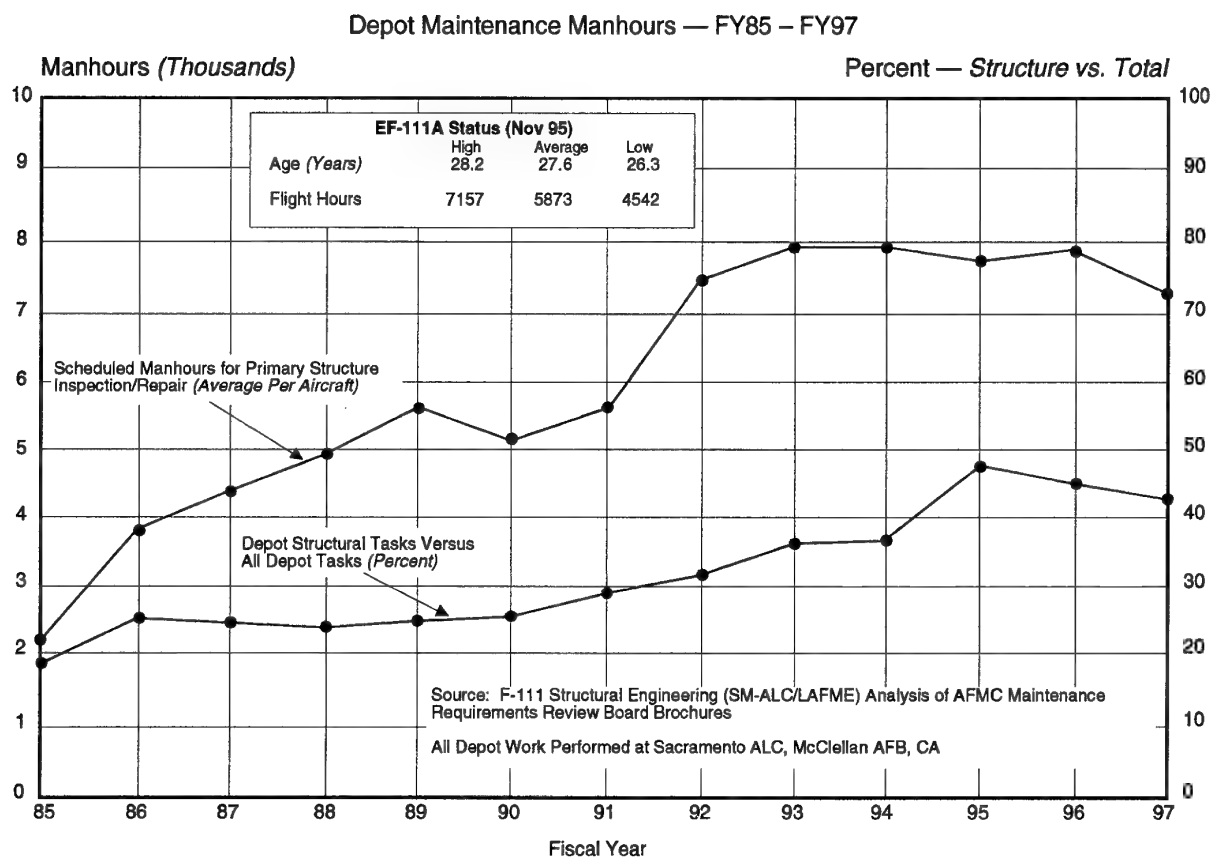
Figure 1. EF-111A Structural Inspection History

The aspect of maintaining aging aircraft cannot be overstated as Figure 1 [1] shows. It may be seen that for the EF-111A aircraft, on an average, the man-hours required for scheduled inspection and repair of each aircraft in the depot has risen from about 2200 hours in 1985 to about 8000 hours today. The figure also shows how much more expensive the cost of maintaining the airframe structure of an aging aircraft is relative to other systems. In 1985, structure-related

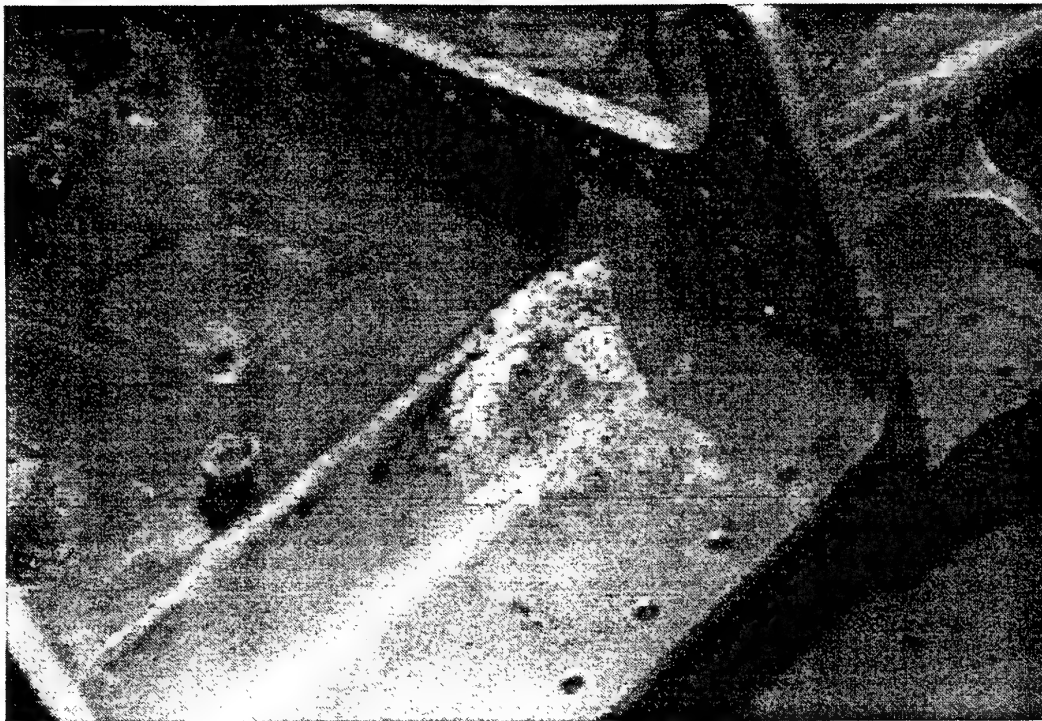
Figure 5. Corrosion/Fatigue

Another significant form of material and structural degradation is corrosion and its potential interactions with fatigue. Such damage is illustrated in Fig. 5. Corrosion is currently a major problem for the C/KC-135 transport and tanker aircraft. Analysis methods are being developed for predicting the detrimental effects on structural integrity of corrosion and its potential interactions with fatigue. It should be noted that corrosion sites are also potential sites for widespread fatigue damage. Hence, it may be necessary to couple the complex phenomenon of corrosion/fatigue

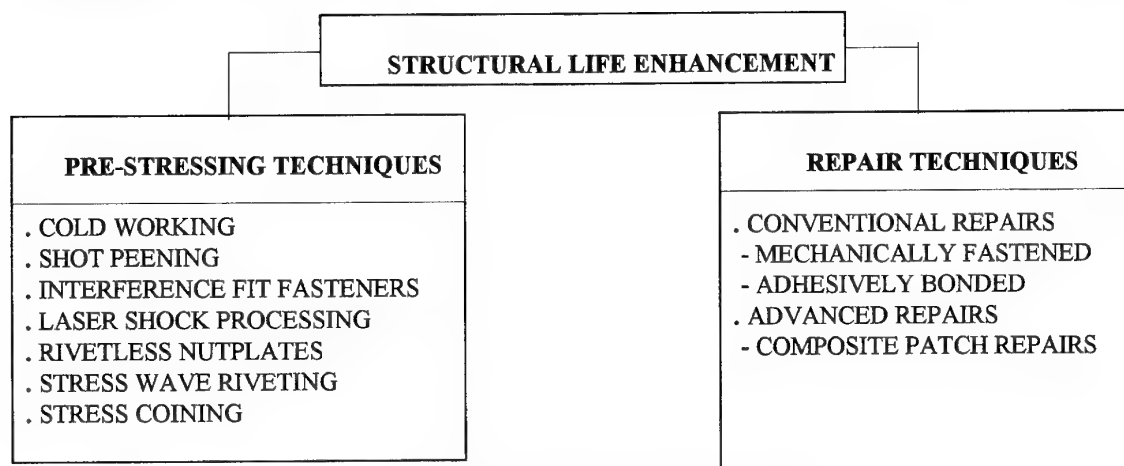
Figure 1. Life Enhancement Techniques

The life of an aircraft structure depends on the applied stresses, environments, structural details and the material of the structural component. Under certain loading and environmental conditions a crack may initiate and propagate in a metallic structural component. Depending on the structural details, the crack may result in a catastrophic failure or costly repairs. A logical preventive method is to retard the initiation and growth of the cracks by prestressing so that the cracks do not result in catastrophic failure before the useful life of the structure. In certain cases this may not be feasible and a structure may have to be repaired to meet the useful life requirements. In addition, the in-service damage in both metallic and composite structures frequently requires repairs so that the structure is able to carry the required load. The structural life enhancement techniques by prestressing and repairs are summarized in Figure 1.

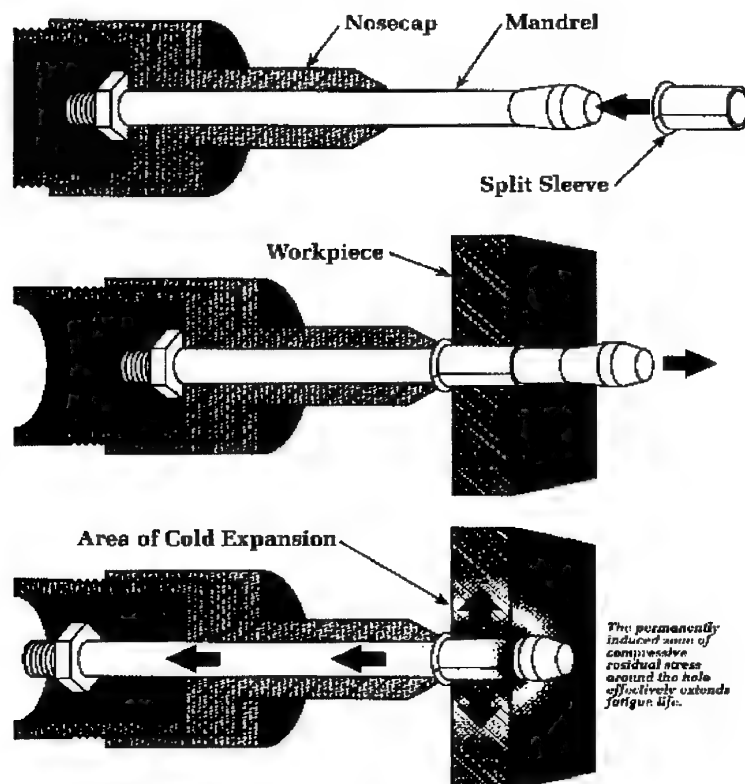
FIGURE 4. Cold Working Process Using Split Sleeve

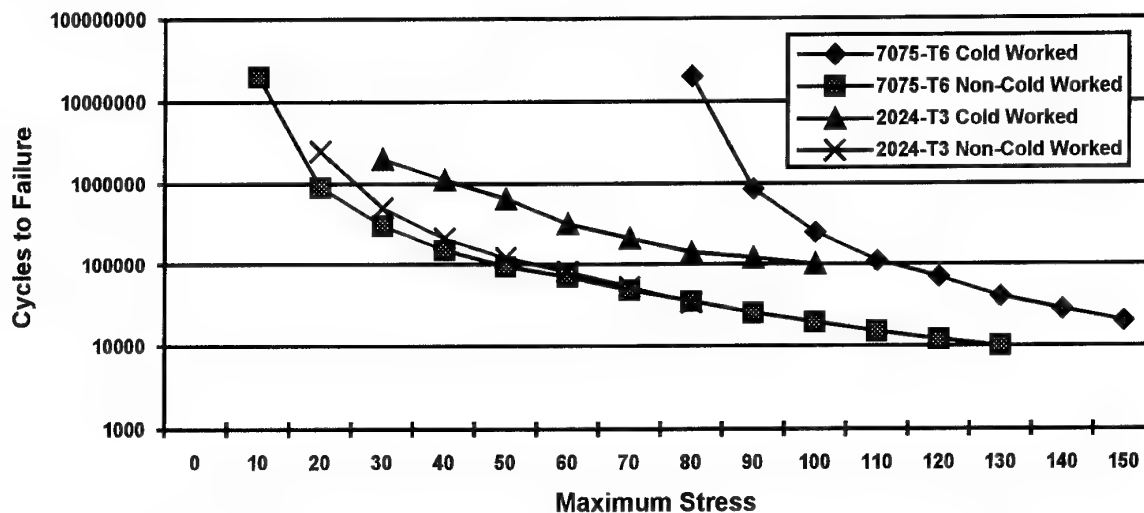
The fatigue life improvements shown in Figure 5 are for constant amplitude loading. The life improvements under spectrum loading are generally smaller compared to constant amplitude loading due to possible relaxation of residual stress under service loads. Under spectrum loading, fatigue life improvement factors of 3 to 5 were found for 2024-T3 and 15 for 7075-T6 aluminum lugs in Ref. 3. Improvements of a similar nature for flight simulated loading have been reported for mechanically fastened joints in Ref. 9 and 2024-T3 open holes in Ref. 10. These test results indicate that relevant testing under spectrum loading must be done for any new life improvement technique and that constant amplitude fatigue testing is not inadequate.

Figure 5. Effect of 3% Hole Expansion on S-N Curves of 7075-T6 and 2024-T3 Aluminum for 3 % Hole Expansion

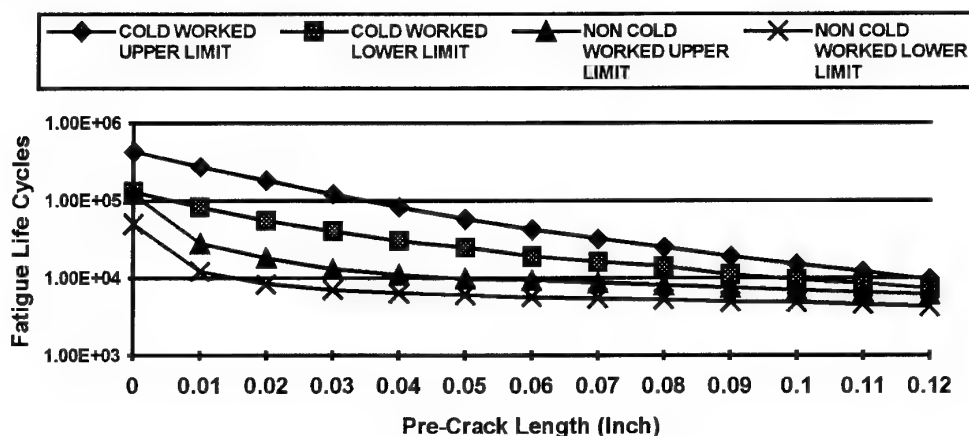
The effect of pre-crack on the crack growth life of 7050-T7 aluminum has been investigated in Ref. 11 for constant amplitude loading. The specimens that contained pre-cracks of lengths of 0.02, 0.05, 0.08 and 0.12 (0.5, 1.25, 2.0 and 3.0 mm) were tested under constant amplitude loading with  $R=0.1$  and a maximum stress of 30 ksi (207 MPa). The cracks in cold worked specimen were introduced prior to cold working. The retained expansion at the hole was about 2.2 percent. The upper and lower bounds of the fatigue life data for cold worked and non-cold worked holes are shown in Figure 6. The figure shows that the improvement in fatigue life depends on the initial crack length. Shorter crack lengths providing a larger increase in life.

Figure 6. Effect of Pre-Crack Length on Fatigue Life of 7075-T7 Aluminum

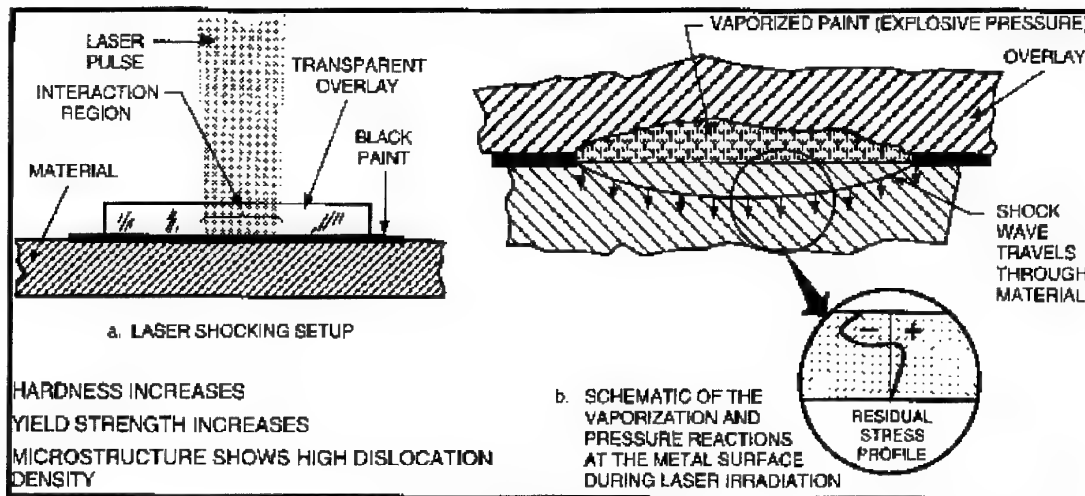
This process involves shooting a laser pulse onto the surface of a part that is covered with black paint and a transparent overlay. The vaporization of the paint sends a shock through the material causing a change in the microstructure of the material with an increase in the hardness and a residual compressive layer as shown in Figure 9. Most of the work in this area has been done by Battelle and the application has been limited to testing only. The testing has shown an early initiation and reconfiguration of cracks. The net result was a substantial reduction in crack growth rate for aluminum alloys. The process was found to be more effective in thin sections (0.125 inch) as compared to thick sections (Ref. 19-20). Extensive testing is required to qualify the process.

Figure 9. Laser Shock Process

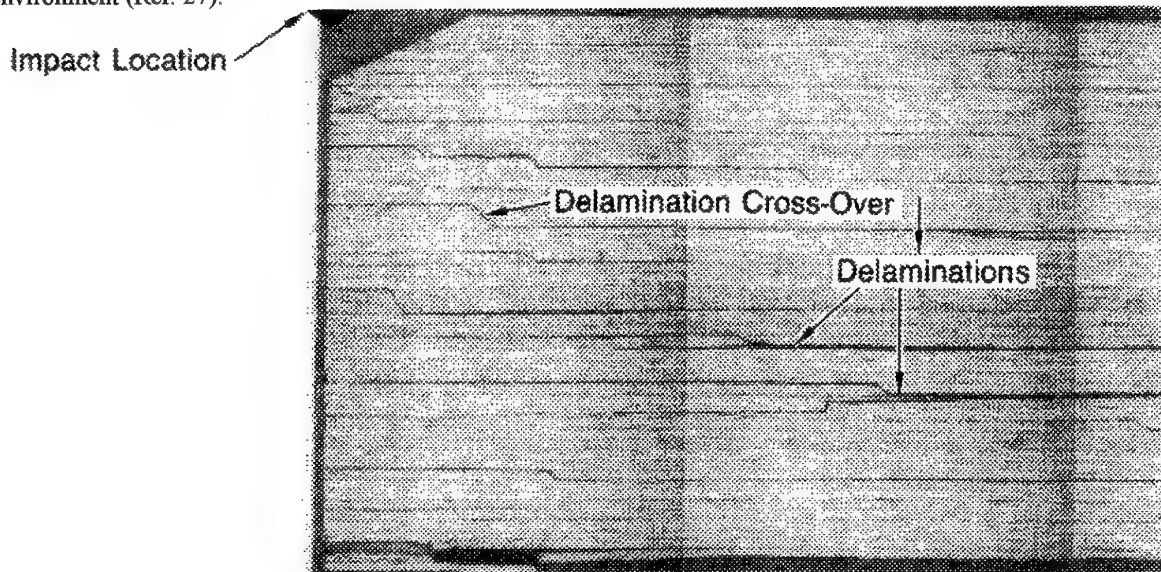
One of the most important design consideration in the design of composite structures is the in-service impact damage. Impact damage can occur during ground handling and also during landing, take-off, and in-flight due to foreign object damage. Impact damage may be caused by hard objects (e.g. tool drops and runway debris) and soft objects (e.g. bird impacts that occur at low altitude during take-off and landing). The impact damage caused by tool drops, etc. is termed as low velocity damage. Studies have shown that considerable reduction in compression strength may occur due to low velocity damage that is not visually detectable on the impacted or other external surfaces. The non-visual damage may cause internal damage in the form of delaminations between plies, matrix cracking, and fiber breakage. The longitudinal cross-section of an impact damaged panel is shown in Figure 12. The damage due to impact is influenced by the factors such as laminate material properties, size of the laminate, support conditions, substructure, impactor size and shape, impactor velocity, impactor mass, impact location, and environment (Ref. 27).

**Figure 12. Impact Damage in Composites**

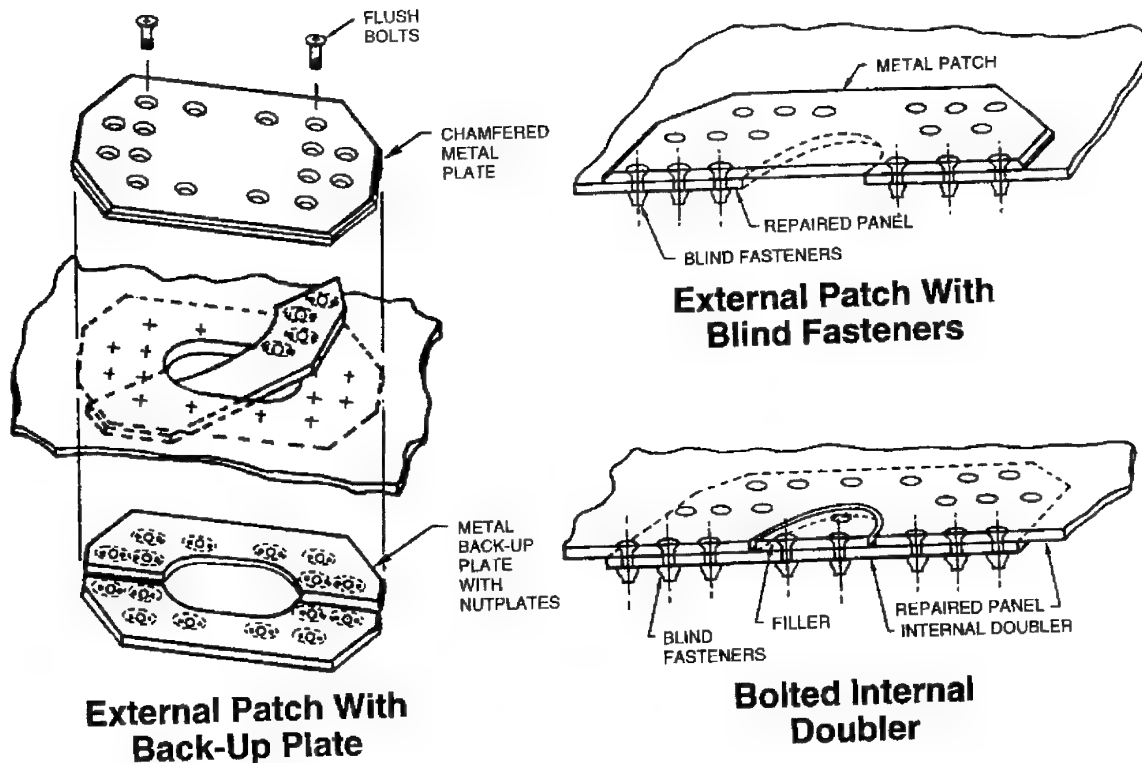
Three commonly used bolted repair concepts are shown in Figure 16 and are discussed here.

Figure 16. Bolted Repair Concepts

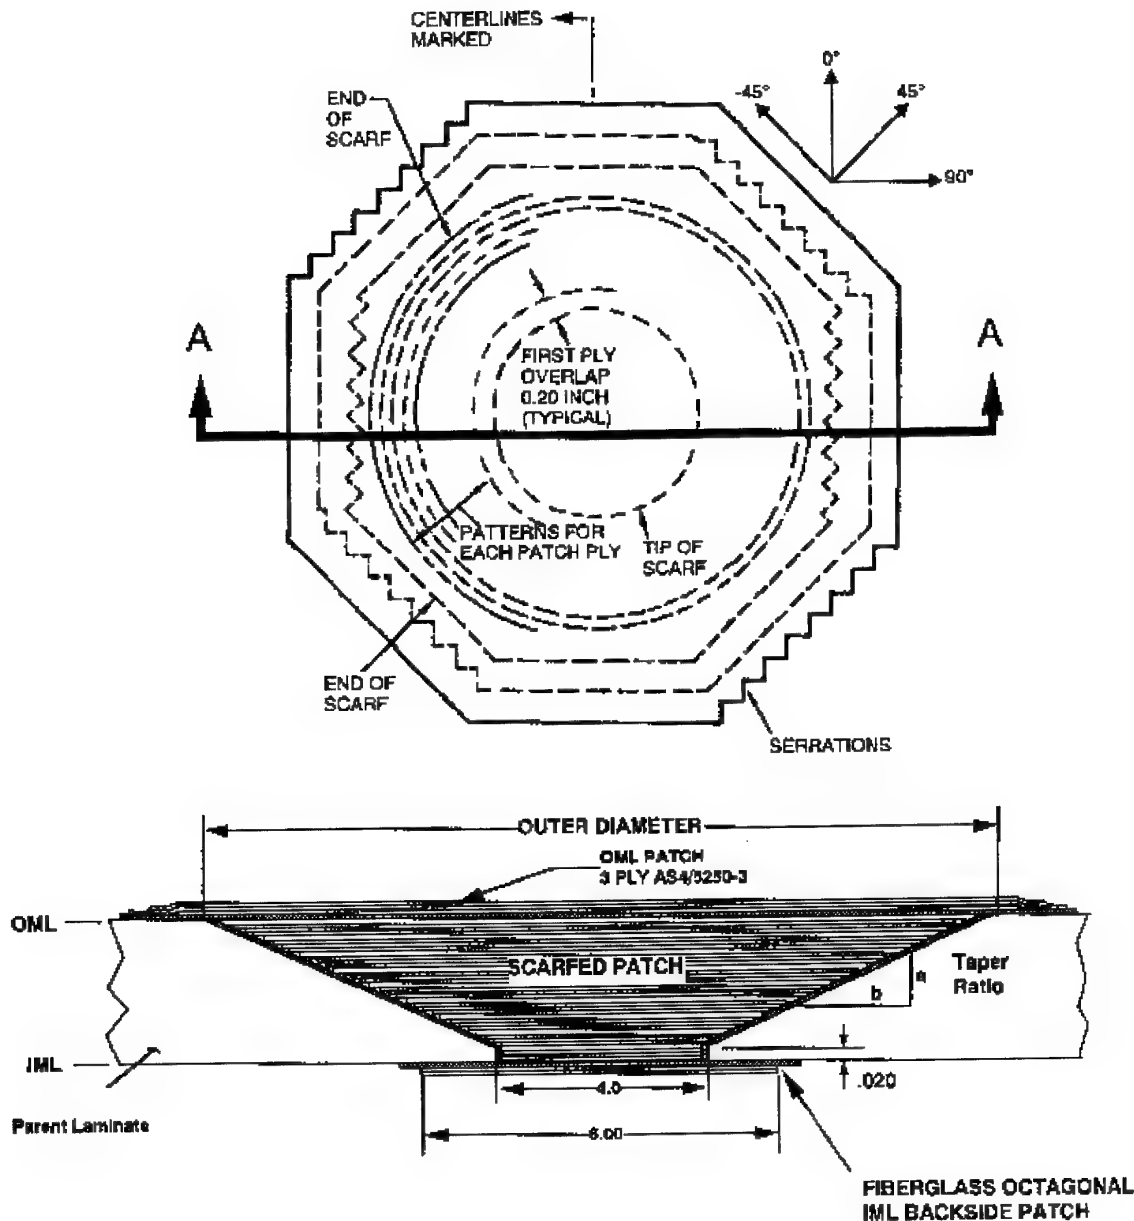
In practice, well made step-lap and scarf joints have approximately the same strength. A disadvantage of step-lap joints is the difficulty in machining the step to the depth of the exact ply that is desired on the surface of the step.

Figure 18. Scarfed Repair

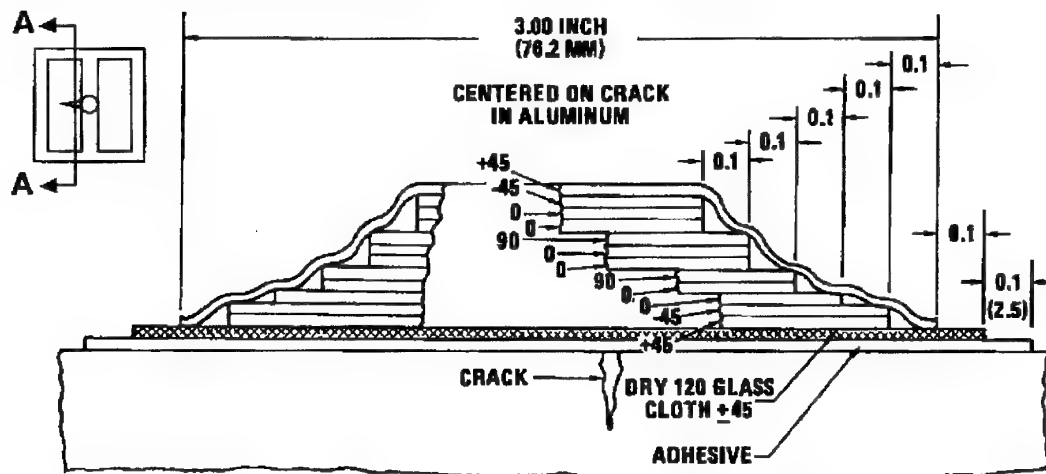
and crack initiation sites due to drilling of holes as in the case of mechanically fastened repairs, 3) High durability under cyclic loading, 4) High directional stiffness in loading direction resulting in thinner patches, and 5) Curved surfaces and complex geometries easily repairable by curing patches in place or prestaging patches. The cross-section of a typical 16-ply graphite/epoxy patch bonded to an aluminum sheet is shown in Figure 19.

Figure 19. Cross-Section of a Typical Composite Repair Patch

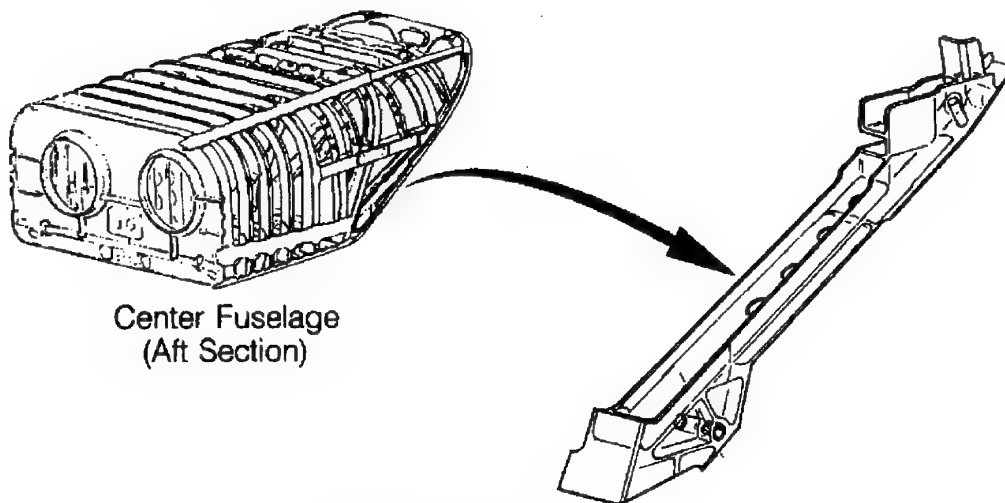
All three candidate parts provided a number of benefits for choosing any of the parts. However, outboard engine mount support (Figure 28) was selected as the best overall part for solving an existing problem while gaining in-service experience. Mechanical properties, obtained from ten forging were found to be within acceptable scatter band. A few engine mount supports have been flying without any known in-service problems.

Figure 28. Engine Mount Support

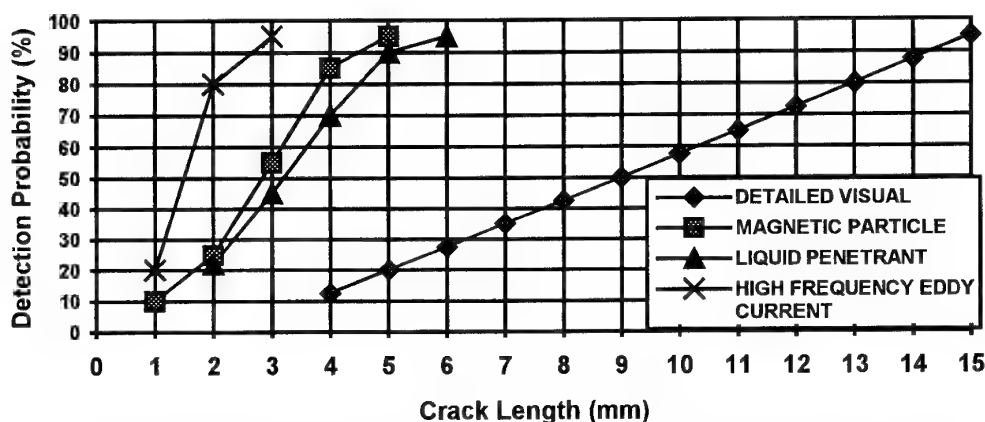
Probability of detection (POD) is a statistically based quantitative measure of inspection capability. The POD is different for different inspection equipment and even for the same NDI equipment is affected by a number of factors such as: material properties, structural details, defect shape, inspection conditions, etc. Another parameter generally associated with POD is the confidence level with which a flaw can be detected. A 95% confidence level is considered acceptable for flaw detection. An NDI equipment capability is generally designated as 90% probability of detecting a flaw with 95% confidence level. The POD of various NDI equipment for through the thickness damage (Ref. 3) is shown in Figure 3. Figure 4 shows POD for sub-surface and internal defects. These figures indicate that the probability of detection varies significantly with each NDI equipment.

Figure 3. Probability of Detection for Through the Thickness Defects

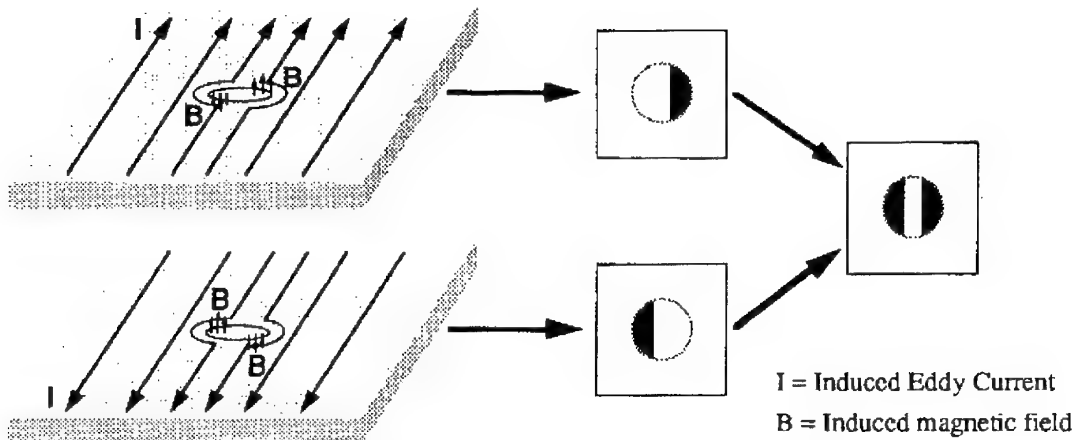
The key advantages of MOI are (Ref. 5): 1) Speed of operation 5 to 10 times faster than conventional eddy current, 2) Easy to interpret image formation, 3) No false calls, 4) Elimination of paint or decal for inspection, 5) Easy documentation of results on video or film, and 6) No operator fatigue.

Figure 6. Formation of Images with Magneto-Optic/Eddy Current Imaging

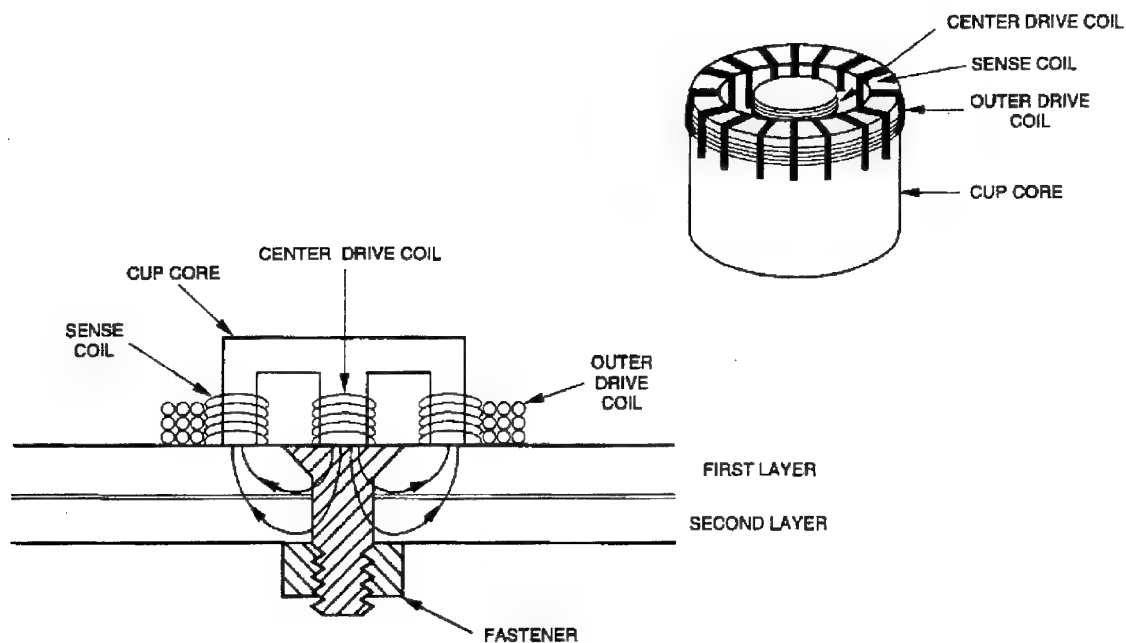
The probability of detection of cracks with the LFECA system was obtained at Federal Aviation Administration (FAA) NDI validation center at Sandia National Laboratories in Albuquerque, New Mexico, USA (Ref. 9-11). The POD process consists of a blind test of eddy current equipment to inspect a lap joint typical of a commercial airline fuselage shown in Figure 12. The process involves inspection of 43 specimens with each specimen containing 20 fastener holes.

Figure 10. Low Frequency Eddy Current Array Probe

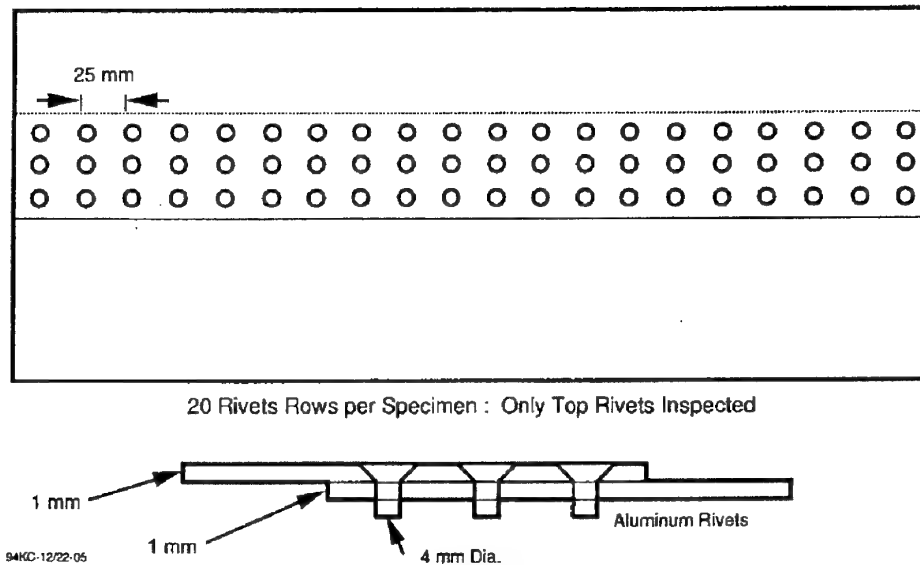
**Figure 12. Boeing 737 Lap Splice Specimen Configuration**

The specimen were constructed using 1 mm thick 2024-T3 aluminum sheets which were fastened together with three rows of 4 mm diameter aluminum flush head rivets. Fatigue cracks were grown in the first layer of selected holes prior to riveting the panels. A range of crack sizes from 0.3 to 25 mm (a hole to hole crack) were grown within  $\pm 22$  degree orientation (0 degrees being the direction from hole to hole). Holes with cracks on one and both sides were present. Specimens contained either none, a low, a medium or a high number of cracks. A total of 860 holes were inspected with 708 being unflawed holes. The validation exercise contained only the first layer cracks under installed fasteners. Figure 13 shows the POD for the LFECA system and conventional eddy current techniques. It is seen that POD obtained with the LFECA system far exceeds that obtained with the conventional system.

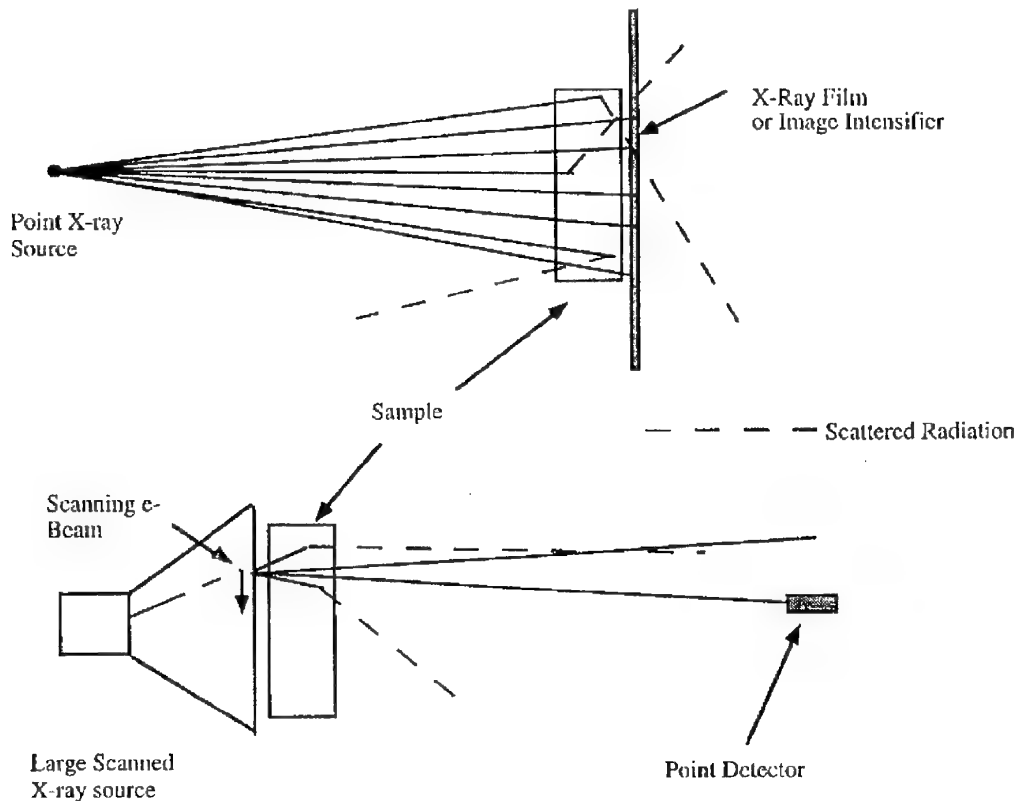
Digiray makes a system which has better resolution and better image quality than the conventional systems. The system is basically the reverse of a conventional digital x-ray imaging system as shown in Figure 15. The x-ray source is formed by a large scanned screen like a TV screen and the detector is a single point sensor as shown in the figure.

Figure 15. Conventional and Reverse Geometry X-Ray Radiography

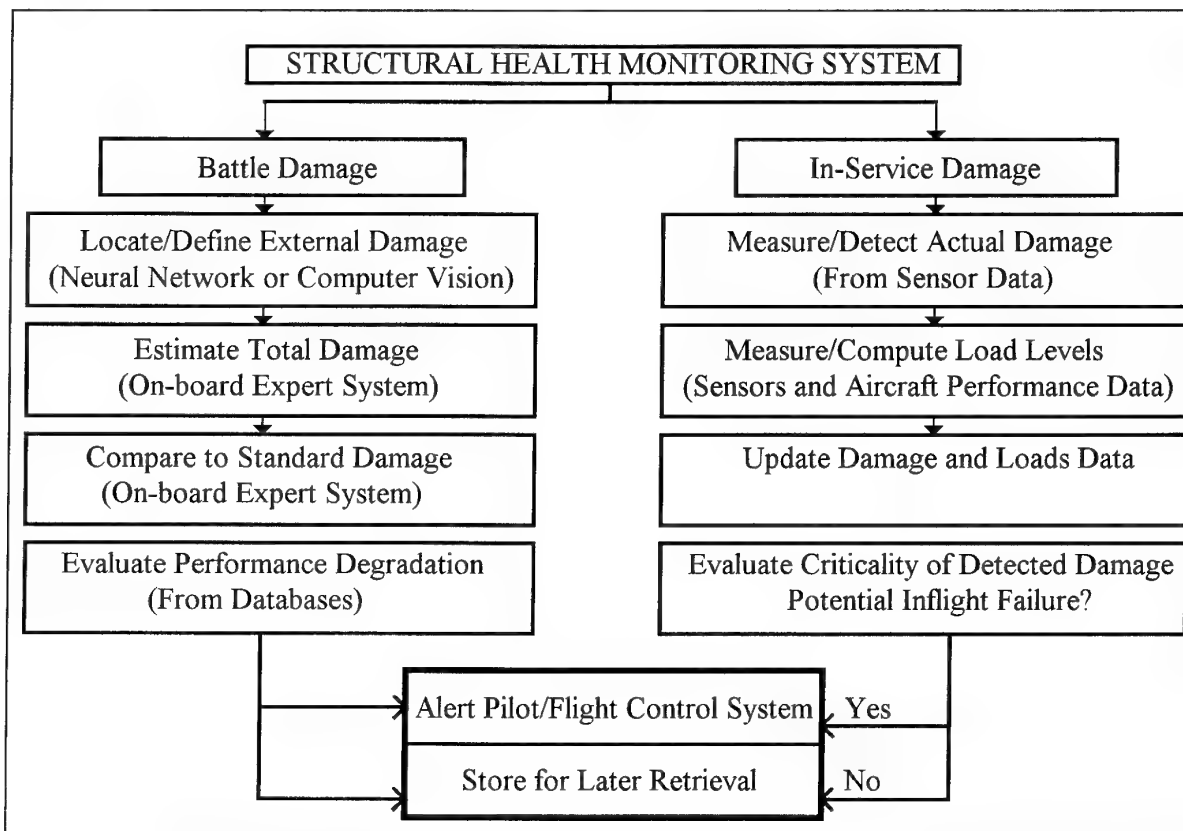
A structural health monitoring system should consider both in-service and battle damage. The SHM procedure (Ref. 1) is outlined in Figure 2. The real time monitoring functions will include battle damage as well as any significant in-service damage. Such damage will cause redistribution of loads in the structure. The long term monitoring will include: impact damage, cracks and corrosion.

**Figure 2. Structural Health Monitoring Procedure**

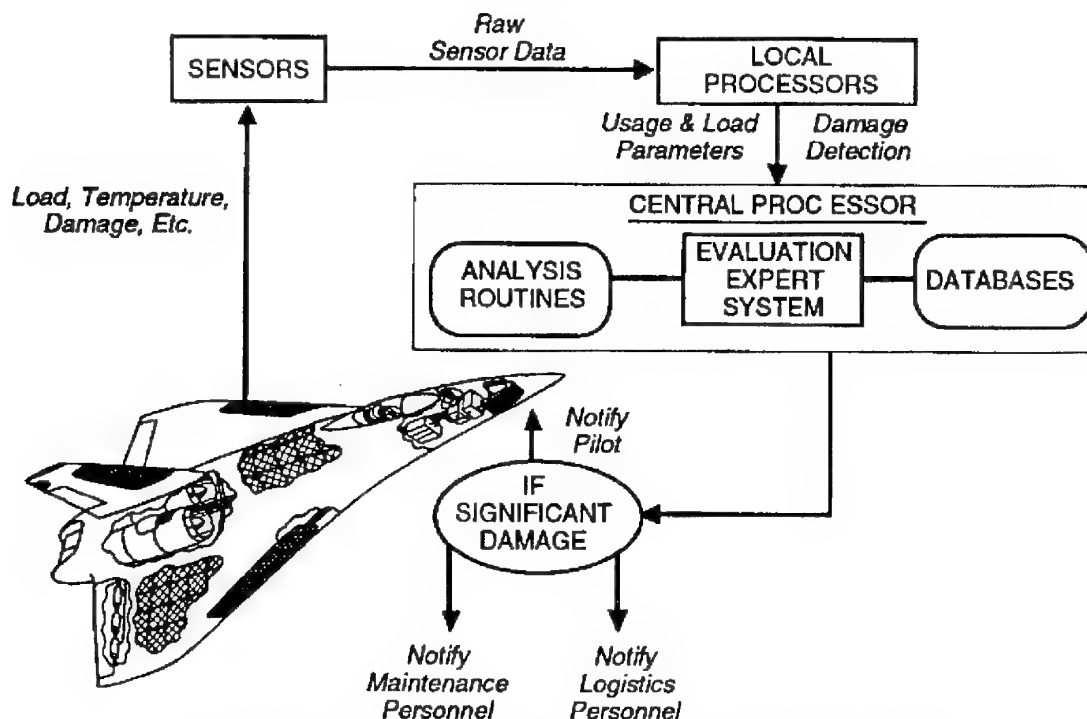
Various components of smart health monitoring system include: 1) Sensors, 2) Local and central processors, and 3) Software capable of making intelligent decisions. A typical smart health monitoring system architecture is shown in Figure 3 (Ref. 1,5).

Figure 3. Structural Health Monitoring System Architecture

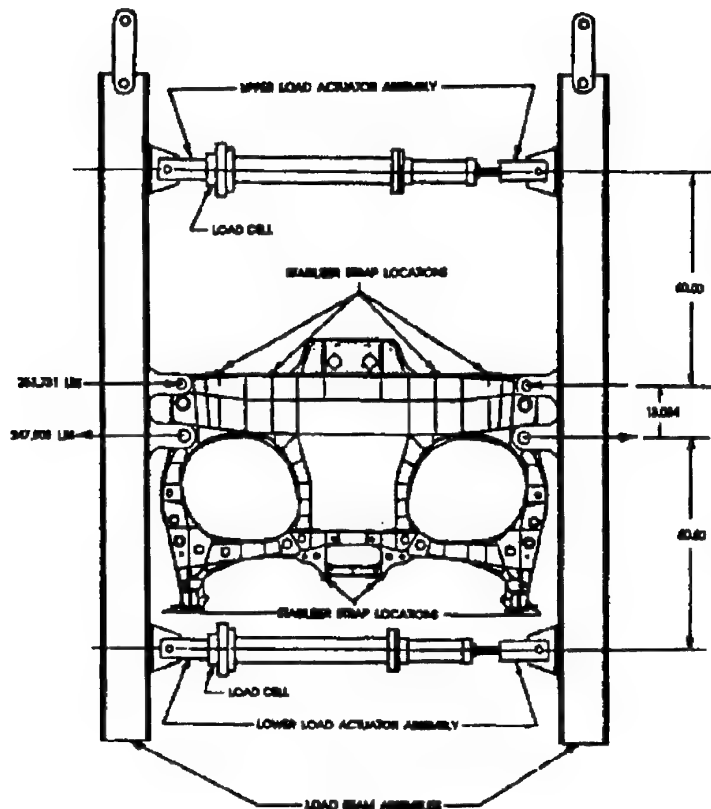
The acoustic emission (AE) technique has shown a good promise for detecting damage in aircraft structures. In Ref. 10 the AE technique was used to remotely detect cracks on an F/A-18E/F titanium bulkhead structural test. The test article, measuring 100 inches (2540 mm) by 60 inches (1524 mm), was the fuselage station 491 titanium bulkhead (Figure 5). The structural fatigue test of the test article consisted of 12,000 hours (2 lifetimes) of spectrum fatigue followed by 6000 cycles of constant amplitude fatigue testing.

Figure 5 F/A-18 E/F Fatigue Test Article

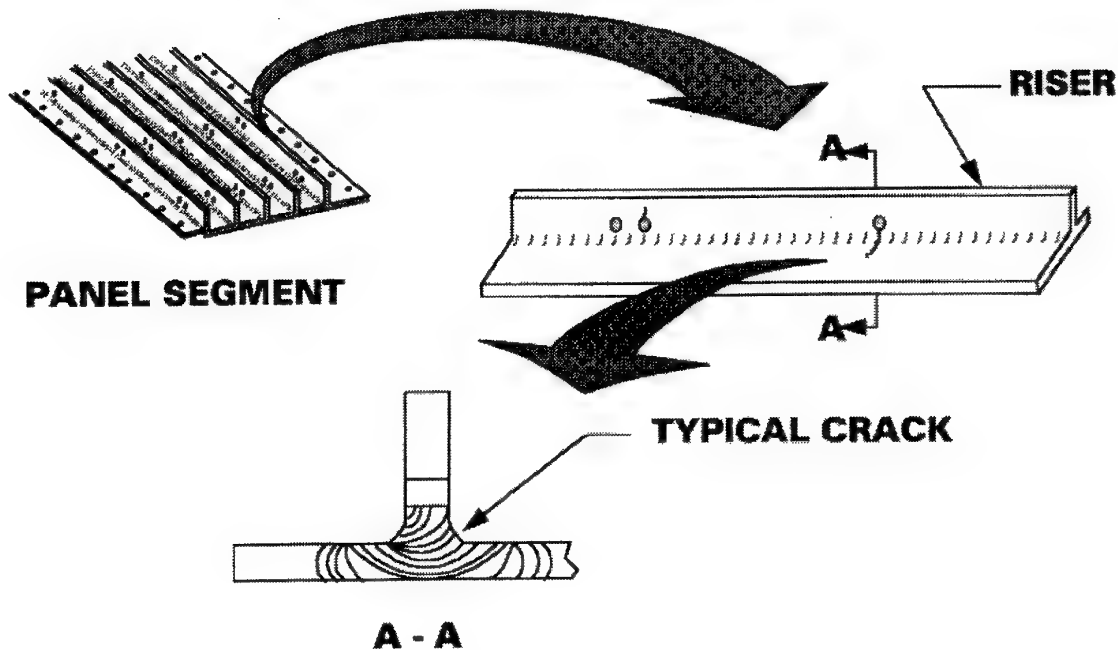
Figure 10. Typical C-141 Weep Hole Cracking

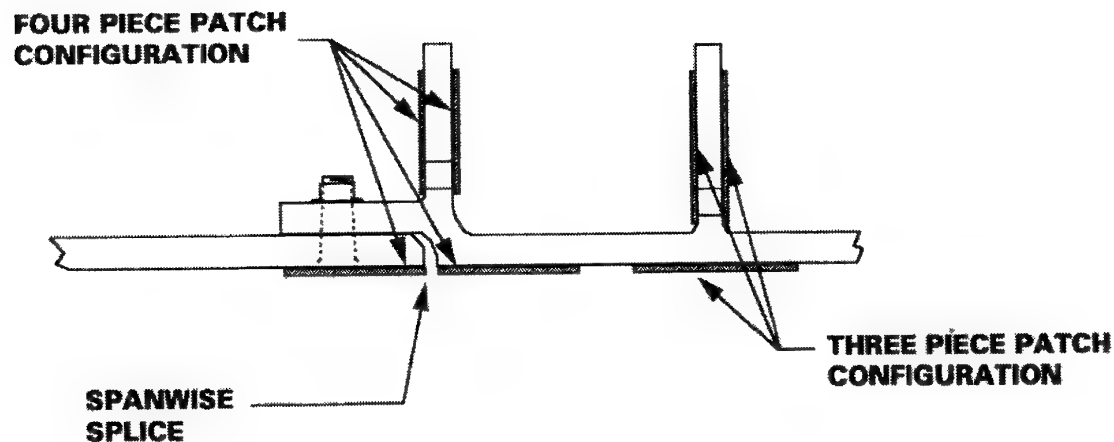
Figure 11. Typical Composite Weep Hole Repairs
